Manhole Inspection Summary

Manhole # S47A__002MH

Insp Date: **6/11/08 9:48 AM**

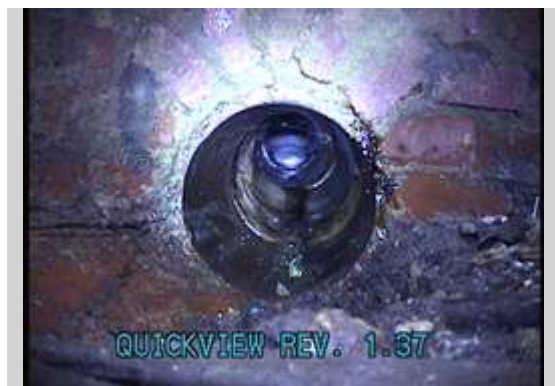
12 O'Clock Outflow

8 in. Circular Gravity Sewer
Pipe Out @ 12 O'Clock

Infiltration: **None** Pipe Seal Cond: **Sound**
